Effective Date: June 18, 2021
Appraised Cash Value: **\$13,332**
Vehicle Year & Make: 1991 Saab
Vehicle Model: 900 convertible
VIN#: YS3AL76L5M7013628
Mileage: 124,859
Engine: 2.0L turbo
Transmission: 3 speed automatic
Client's Name: Ralph Hansen
Phone: 517-896-9508
Certified Inspector/Appraiser: Todd Swales
IACP Certification #: 997911151

Statement of Purpose

This report is to document the in person inspection of the **1991 Saab 900** listed above.

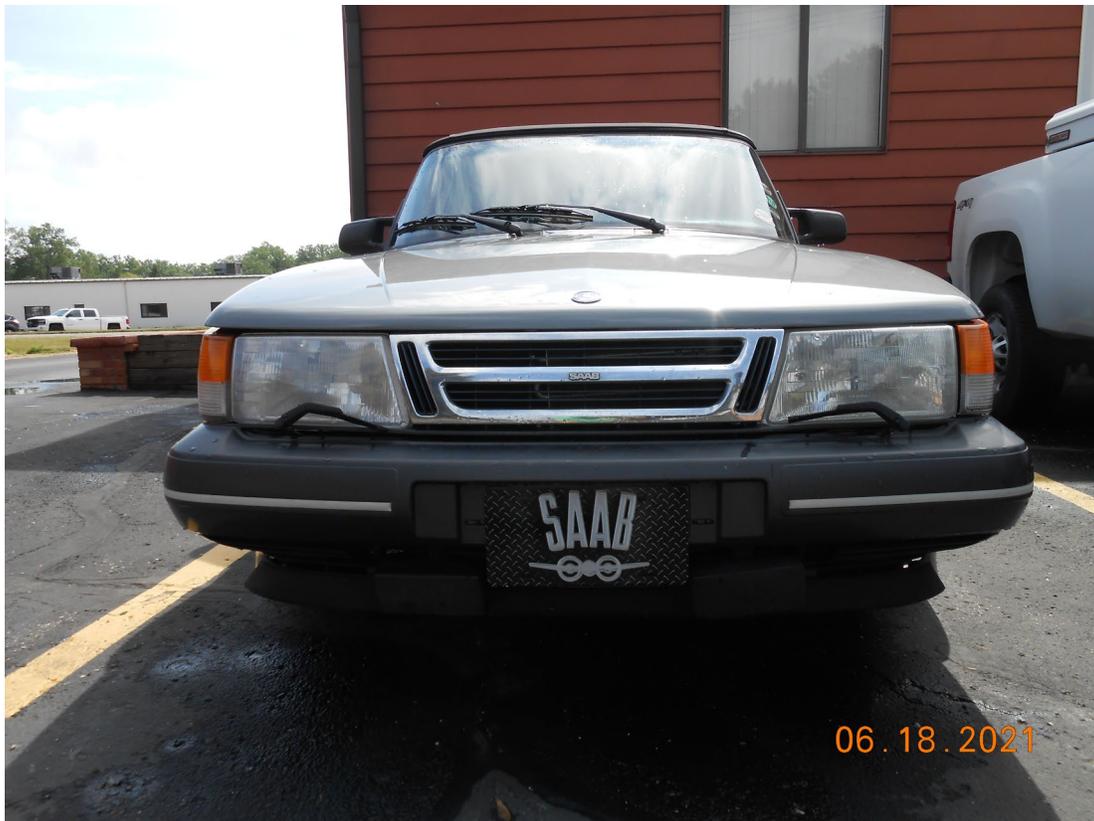
This vehicle is a turbo powered convertible with most likely the original engine and transmission. Overall condition is good to very good for the vintage.

The vehicle underwent a recent repaint, has spent most of its driving miles domiciled in Florida and is rust free.

The exterior has been repainted in a nearly factory color and the paint appears as better than factory quality with better than factory equivalent orange peeling. Limited paint scratches and chips were present and no noticeable body filler or major accident repair was noted.

The lower satin black areas did show some light fading consistent with Florida sun impact and one molding showed some damage.
